LAKE ONEIDA DAM
NDI No. PA - 272

PHASE I INSPECTION REPORT

NATIONAL DAM INSPECTION PROGRAM .

SEPTEMBER 1978

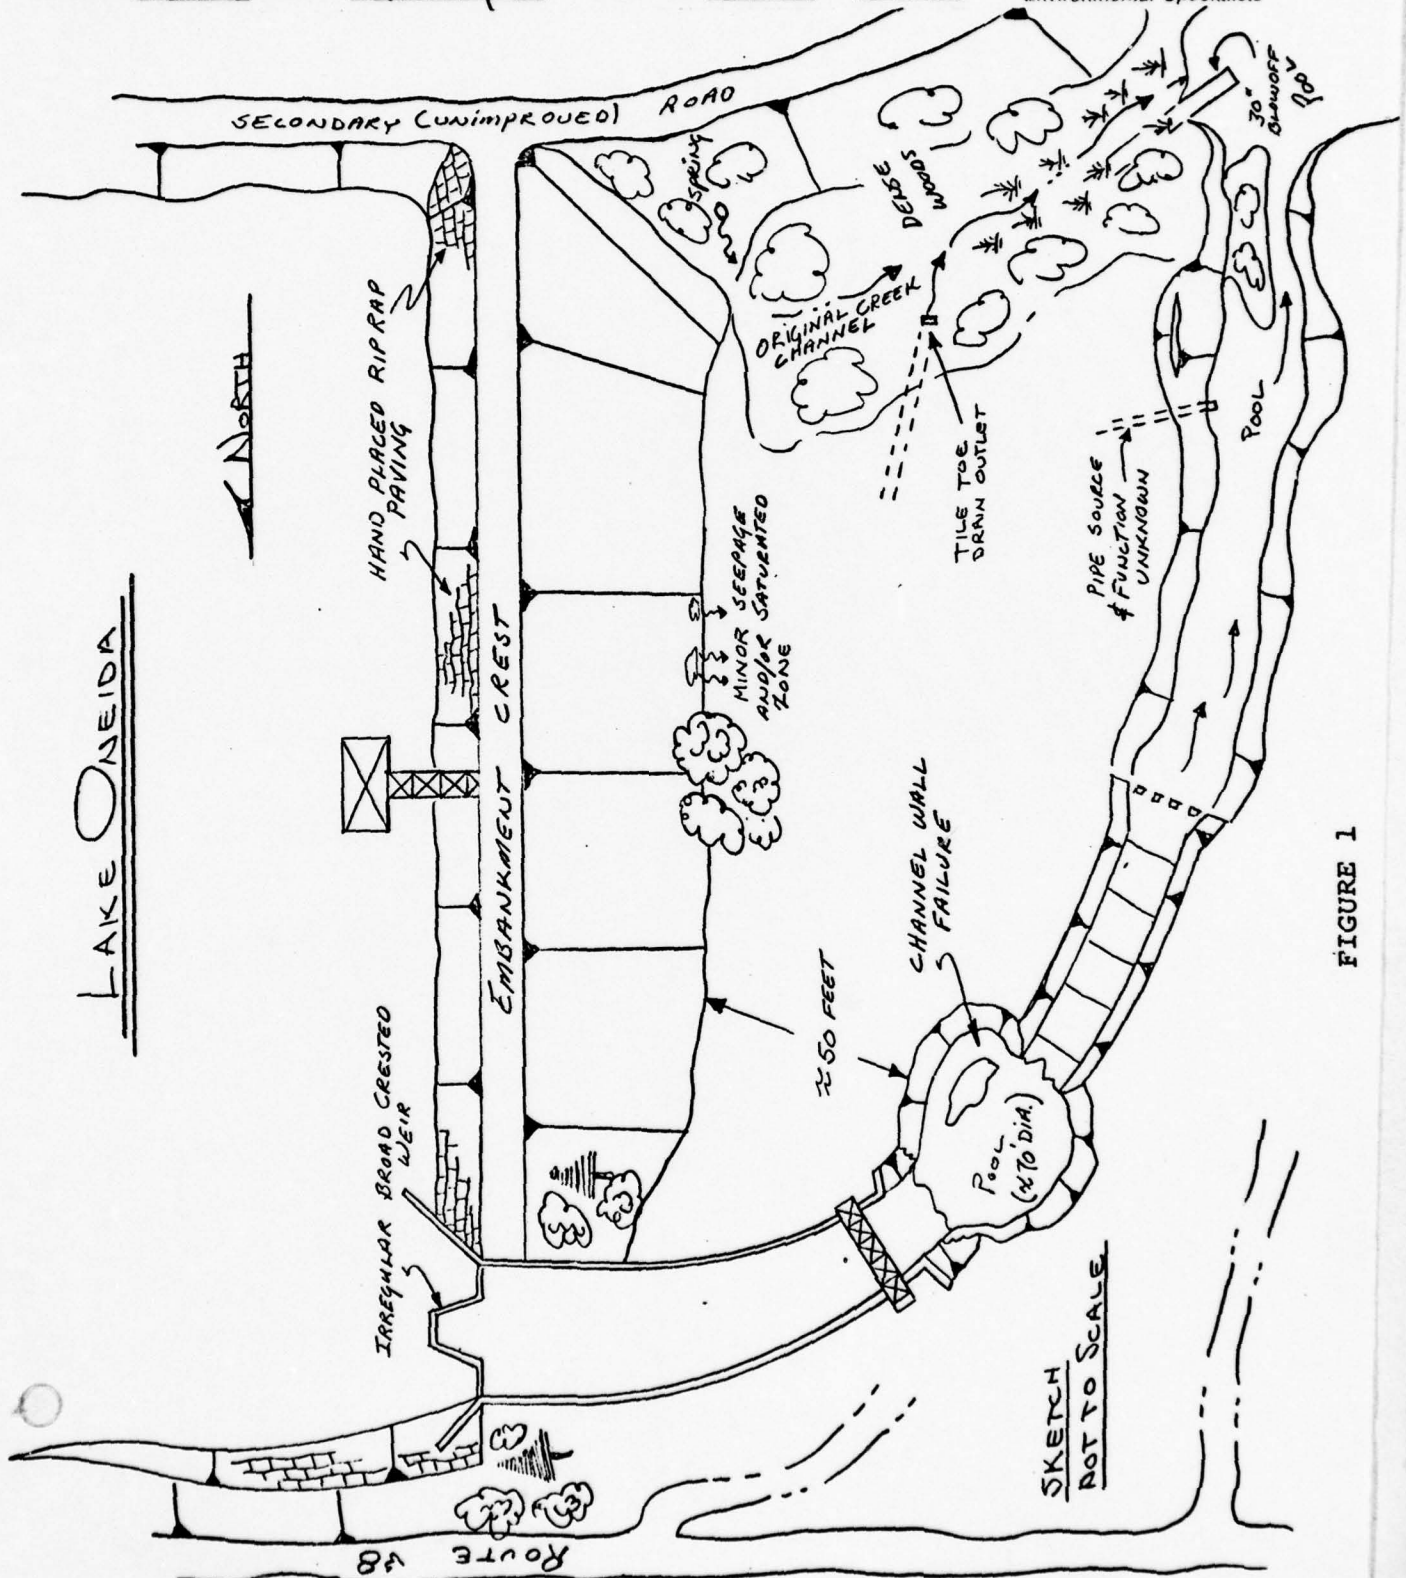
FIGURE 1

Saturated conditions were observed at the toe of the dam in a few areas (see Figure 1). These areas of seepage have been noted in PennDER files since shortly after the embankment was constructed. Flow could not be measured; however, the condition warrants further investigation by a geotechnical engineering experienced in dam design.

ii. To investigate and determine the cause of the seepage observed at the downstream toe of the embankment, its effect on the overall stability of the embankment, as well as the piping potential, and recommend remedial measures if necessary.
